Salient
Marine Surveys

REPORT OF CONDITION SURVEY ON “EXAMPLE” BENETEAU ANTARES 6

Date: 08/05/14

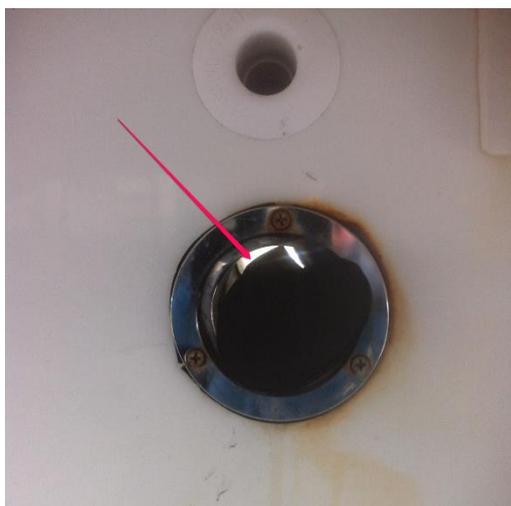
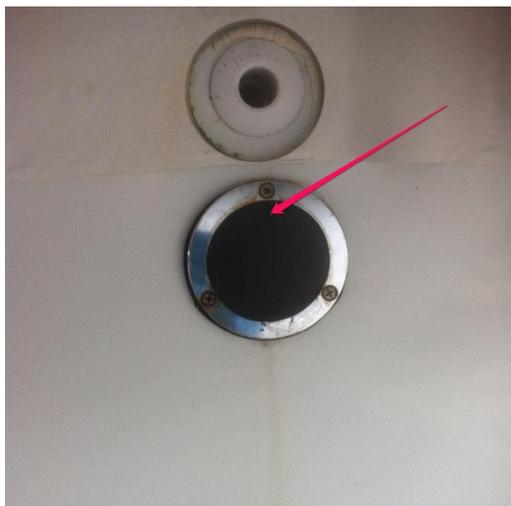
There are two aft cockpit drains located port and starboard in the transom, these have rubber flaps to prevent water coming into the cockpit when motoring astern or in a following sea. Both these flaps are perished and split. *It is recommended these flaps are replaced prior to re launching the boat.*

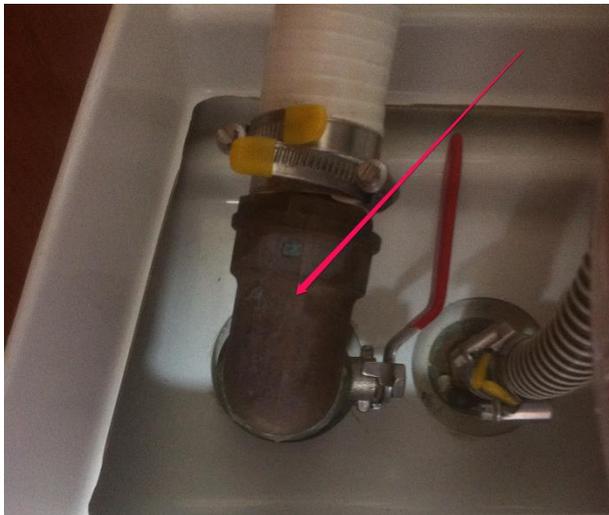
1) Forward sea toilet discharge ball valve was found to be securely double clipped with no visible signs of defect. The ball valve handle was found to be extremely stiff to operate. *It is recommended that this ball valve is serviced before the vessel is re launched.*

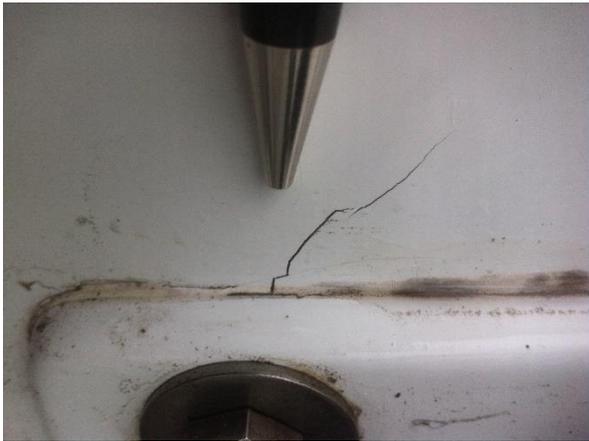
The hull is internally reinforced with a separate floor moulding which is bonded to the hull made up of longitudinal stringers and athwart ships sections. There is a bulkhead forward to the anchor locker. The plywood face has a removable panel to access the electric windlass, this was removed and an inspection showed no visible signs of defects, even though as mentioned in section F4, the gel coat has cracked in the other side of this panel from excessive tension from the electric windlass.

The Lewmar electric windlass, mounted in the anchor locker is bolted to a bulkhead. This bulkhead is deflected forward by up to 4mm and cracks in the gel coat have formed at the top joint and corners.

This has been caused by excessive tension applied to the anchor chain by the operator of the electric windlass, the windlass is also oversized for the size of vessel and anchor. This means that it needs to be operated

carefully to ensure that excessive tension is not applied that may damage the mooring gear. No winch handle could be located to operate the windlass clutch manually.

The bulkhead requires strengthening to take the forces of the large electric windlass. The back of this bulkhead is easily accessible from the cabin and a substantial piece of plywood or stainless steel can be bolted to the bulkhead aperture to increase strength. The gel coat should be "Vee'd" out and repaired with gel coat paste. Care should be taken when operating the electric windlass to ensure that excessive tension is not applied. In addition, a method of holding the anchor secure without using the electric windlass is recommended, as leaving the electric motor in the windlass under tension for long periods shortens the life of the motor. Alternative securing of the anchor can include a pin fixing through the bow roller, or a rope to take tension back to a secure point in the anchor locker. A winch handle should be acquired and secured in the anchor locker to operate the windlass clutch manually.

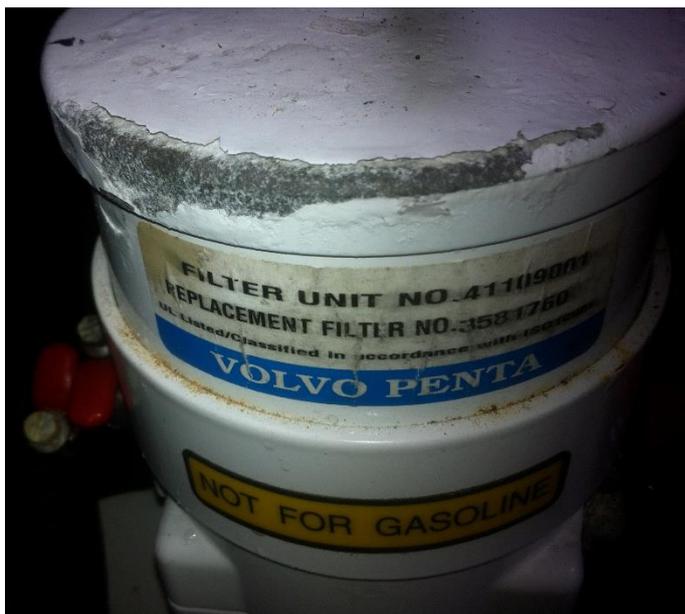
The primary Diesel fuel filter is showing signs of corrosion, whilst this is only a cosmetic issue, you may consider having this taken back to bare metal, an alloy primer and appropriate paint to bring this back to good condition.
