Salient
Marine Surveys

REPORT OF CONDITION SURVEY ON “EXAMPLE” BENETEAU ANTARES 6

Date: 08/05/14

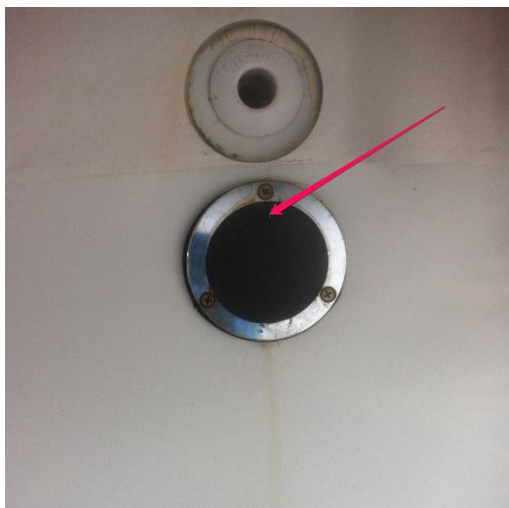
There are two aft cockpit drains located port and starboard in the transom, these have rubber flaps to prevent water coming into the cockpit when motoring astern or in a following sea. Both these flaps are perished and split. *It is recommended these flaps are replaced prior to re launching the boat.*

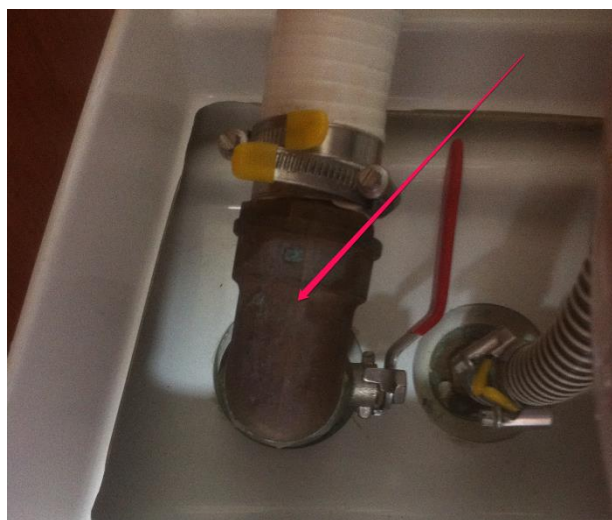
1) Forward sea toilet discharge ball valve was found to be securely double clipped with no visible signs of defect. The ball valve handle was found to be extremely stiff to operate. *It is recommended that this ball valve is serviced before the vessel is re launched.*

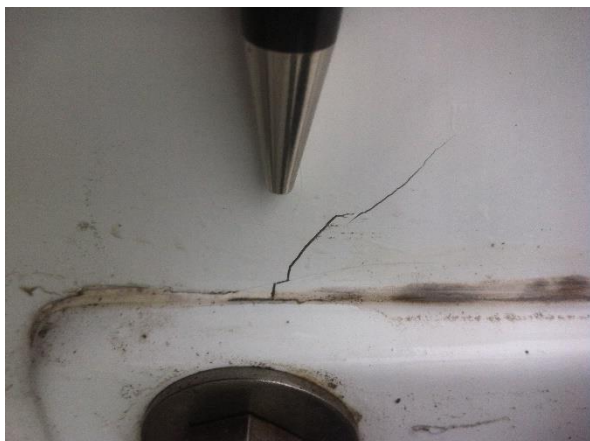
The Lewmar electric windlass, mounted in the anchor locker is bolted to a bulkhead. This bulkhead is deflected forward by up to 4mm and cracks in the gel coat have formed at the top joint and corners.

This has been caused by excessive tension applied to the anchor chain by the operator of the electric windlass, the windlass is also oversized for the size of vessel and anchor. This means that it needs to be operated

carefully to ensure that excessive tension is not applied that may damage the mooring gear. No winch handle could be located to operate the windlass clutch manually.

The bulkhead requires strengthening to take the forces of the large electric windlass. The back of this bulkhead is easily accessible from the cabin and a substantial piece of plywood or stainless steel can be bolted to the bulkhead aperture to increase strength. The gel coat should be "Vee'd" out and repaired with gel coat paste. Care should be taken when operating the electric windlass to ensure that excessive tension is not applied. In addition, a method of holding the anchor secure without using the electric windlass is recommended, as leaving the electric motor in the windlass under tension for long periods shortens the life of the motor. Alternative securing of the anchor can include a pin fixing through the bow roller, or a rope to take tension back to a secure point in the anchor locker. A winch handle should be acquired and secured in the anchor locker to operate the windlass clutch manually.

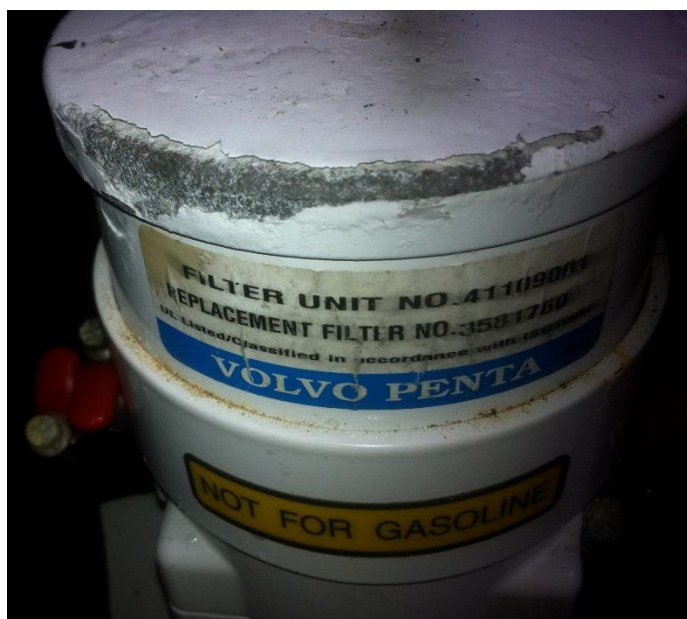
The primary Diesel fuel filter is showing signs of corrosion, whilst this is only a cosmetic issue, you may consider having this taken back to bare metal, an alloy primer and appropriate paint to bring this back to good condition.
