Salient
Marine Surveys

REPORT OF CONDITION SURVEY ON “EXAMPLE” BENETEAU ANTARES 6

Date: 08/05/14

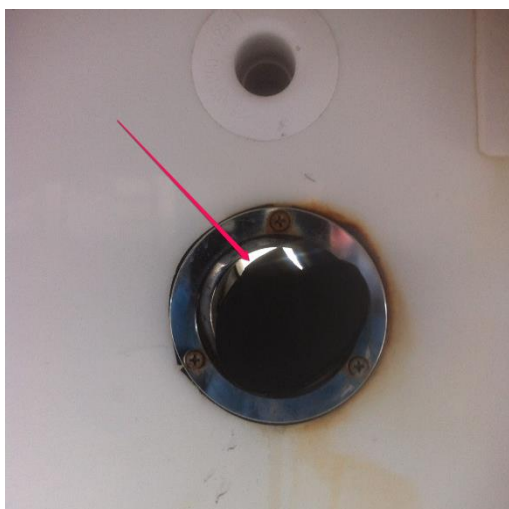
There are two aft cockpit drains located port and starboard in the transom, these have rubber flaps to prevent water coming into the cockpit when motoring astern or in a following sea. Both these flaps are perished and split. *It is recommended these flaps are replaced prior to re launching the boat.*
